Visual Termite Inspection Report in accordance with AS 3660.2-2000

CONTACT & SITE DETAILS	
Inspection Requested By:	WHITTLES BODY CORP GPO Box 1513 Darwin NT 0801
Site Contact:	
Site Address:	Lot: 4833, 17 Cormorant St Bakewell 0832
Job Number:	141928
Date of Inspection	23/02/2021

1. STRUCTURE	
Type:	Unit
Height:	Multistorey
Building:	Rendered concrete
Piers:	Concrete
Floor:	Concrete Slab
Roof:	Metal Sheeting
Fences:	Timber, Blockwork, Aluminum

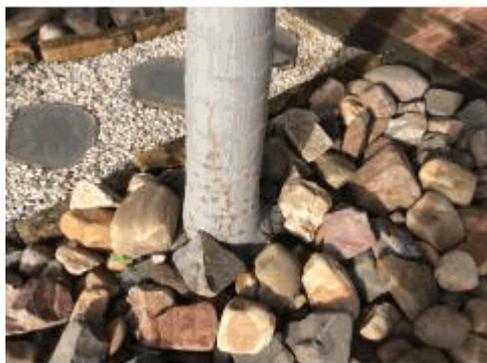
2.0 SUBTERRANEAN TERMITES	
2.1 At the time of the inspection were active termites (live insects) found?	Yes, termites were located at the time of the inspection and have the potential to cause extensive to sever damage to all timbers, including structural timber. When live termites are located within a building, there are possibilities that activity may have been present for long periods of time.
Active termites were located in but not necessarily limited to the following areas:	Trees 6 X LOCATIONS
Other areas, if any, where active termites were found are:	
If the answer was "Yes" then the termites are believed to be:	Microcerotermes species Microcerotermes species
The termites have the potential to cause:	moderate to extensive
Other termite species found at the time of the inspection were:	Microcerotermes species
2.2 A termite nest was found in (state the location):	Trees

Where a termite nest is located on or near the property, the risk of termite infestation is increased.

TERMITE DAMAGE	
2.3 At the time of the inspection was visible evidence of subterranean termite workings and/or damage located?	Yes
Termite damage and/or workings were found mainly in but not limited to:	Trees

Recommendation: Due to active termites, a Termite Management Program be undertaken immediately.,
Treat termite activity in grounds our price \$154 Inc GST

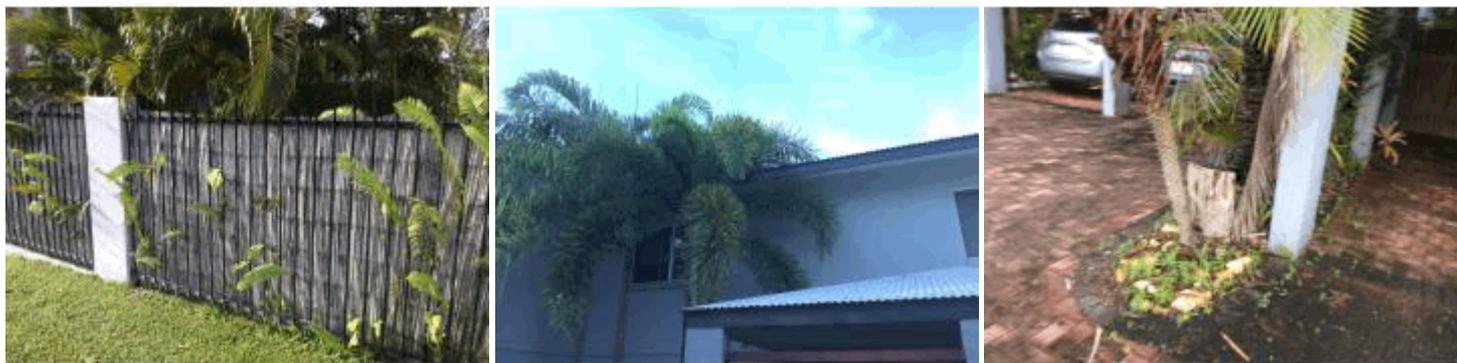
OTHER CONDUCTIVE CONDITIONS	
2.10 Other areas and/or situations that appear conducive to (may attract) subterranean termite infestation:	Fences - [bamboo fence in ground contact that may attract and/or conceal termite activity] , Touching structure - [Trees touching structure that may attract and/or conceal termite activity.] , Grounds - [Old tree stumps that may attract and/or conceal termite activity]

, Modify bamboo fence to avoid ground contact (by others), Remove/prune trees touching structure (by others), Remove old tree stumps (by others), Note - all Darwin and surrounding areas are classified as high risk areas,

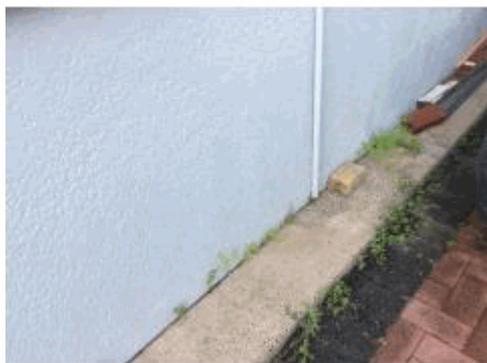
3.3 Hot water services and air conditioning units: which release water alongside or near to building walls need to be connected to a drain as the resulting wet area is highly conducive to termites. If this is not possible the water needs to be piped several meters away from the building as the resulting wet area is highly conducive to termites.

Yes, the air conditioner
